WATER QUALITY MEMORANDUM Utah Coal Regulatory Program

September 15, 2010

RE: 2010 1st Quarter Water Monitoring, Canyon Fuel Company (CFC), LLC, Dugout Mine, C/007/0039-WQ10-1, Task ID #3475

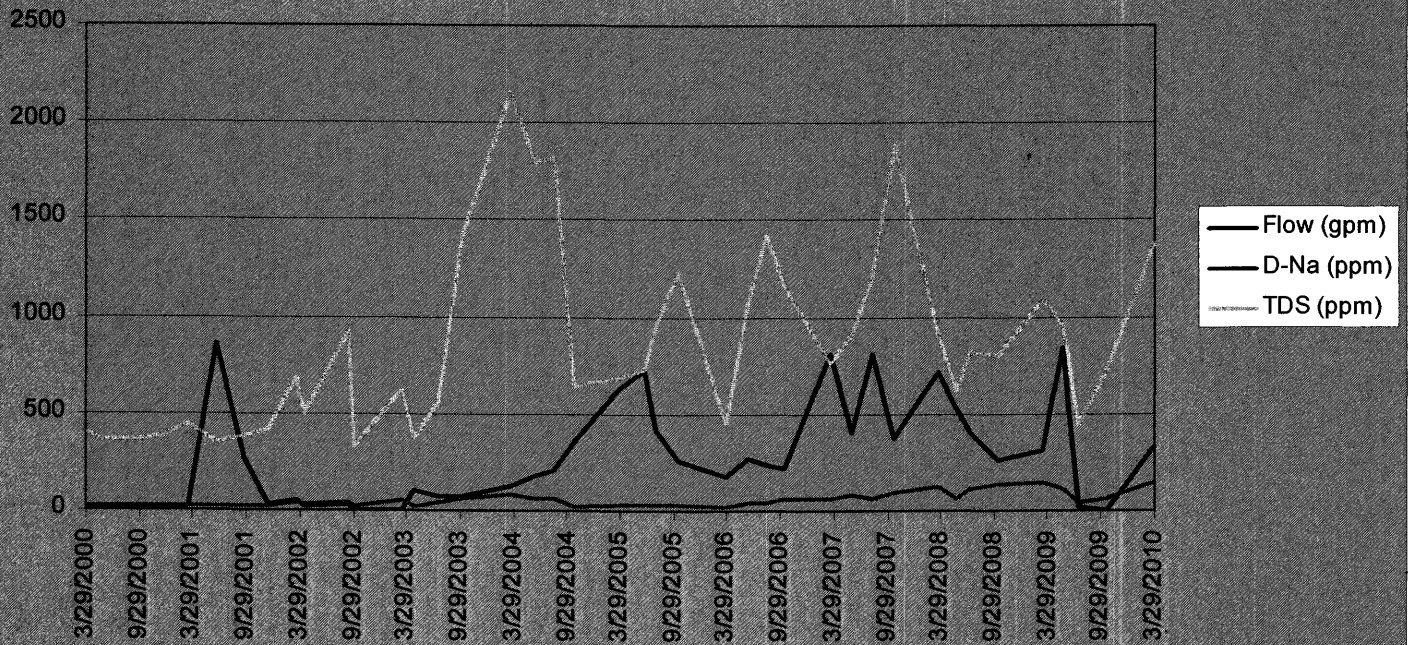
DC-1: D-Na, TDS and Flow vs. Time

DC-1 reported several values outside of two standard deviations of the data set. The site has historically produced erratic D-Na trends typified by spikes in the late spring/early summer. The previous quarter (4th quarter 2009), the reported D-Na value was within two standard deviations of the mean; however, an elevated value was reported this quarter. In addition to D-NA, spikes were reported for field conductivity, Chloride and Bicarbonate. CONTINUED MONITORING

Continued monitoring of stream monitoring sites DC-1, DC-2, FAN and PC-2 for upward trends in TDS and its chemical constituents.

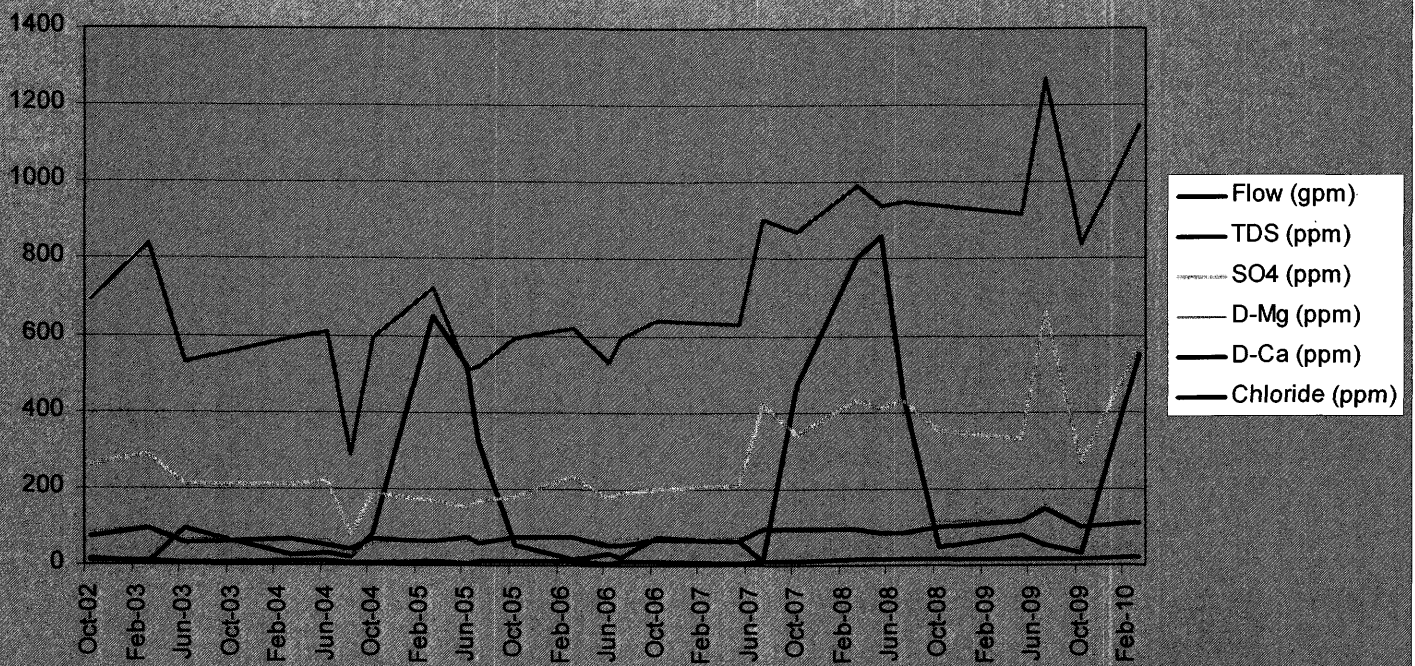
Stream Monitoring Site PC-2

Site PC-2 has developed an upward trend in TDS and its associated components. The previous three quarters had shown an upward trend in TDS and this quarter continued that trend with elevated values reported for field conductivity, D-Ca, D-Mg, D-K, D-Na, Cl, SO₄, TDS, T-Cations and T-Anions (See chart below). The water quality standard for Pace Creek (as established by the Division of Water Quality) is 3,000 mg/L. The reported TDS value for this quarter is 1,150 mg/L. Although the concentrations are well within the standard, continued monitoring will be conducted.
